Fracture of cobalt-chrome modular neck in total hip arthroplasty

Summary. Despite the advantages of modular total hip arthroplasty in terms of neck version, offset and length precise reproduction, titanium necks breakage became a concern. Consequently, titanium has been replaced by cobalt-chrome (Co-Cr). However, four cases of Co-Cr modular neck breakage have been reported in the literature. In the present paper, two cases of Co-Cr modular neck fractures are described together with a literature review. The aim of this work is to discuss the risk factors and characteristics of this rare complication. We described two cases of fracture of long varus Co-Cr modular femoral neck connected with cementless press-fit stem. Some risk factors, such as long varus type of modular neck, overweight and/or high demanding physical activity, might have contributed to implant failure. (www.actabiomedica.it)

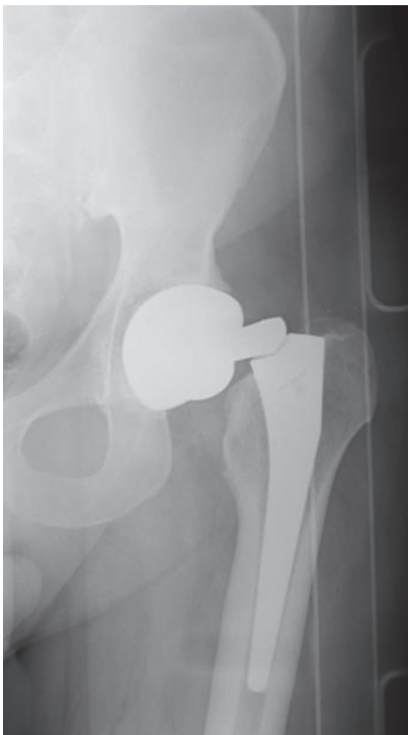
a Biolox Delta size 36 head. Postoperative radiographic control showed a correctly placed hip prosthesis, with a regular post-operative course. The patient resumed his daily activities without limitations or pain. In June 2015 (4 years postoperatively), the patient heard a crack from his left hip while he was jumping from a one-meter high wall. Thereafter, he referred severe hip pain with motion and inability to weight bearing on the affected limb. The patient came at the emergency department at our Institution, where left hip radiographs were taken demonstrating a fracture of the modular neck at the stem-cone junction (Fig. 1a). Both acetabular and femoral components seemed to be well fixed, and the femoral head remained attached to the proximal fragment of the modular neck. There were no clinical, radiographic or laboratory signs of infection.

Figure 1a. Case 1. Left hip AP view radiographs showing a fracture of the modular neck at the stem-cone junction

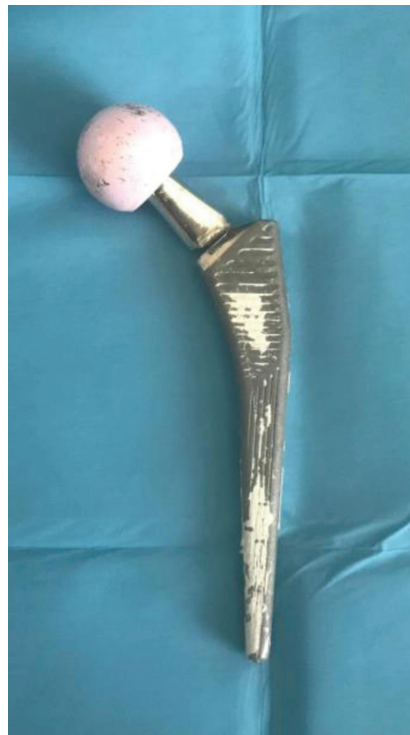
After 4 days, the patient underwent revision total hip arthroplasty through a postero-lateral approach to the left hip. The modular neck fracture resulted to be complete with fragmentation at the stem-neck junction.

Minimal fretting and corrosion damage on the surface that had mated with the femoral stem was observed (Fig. 1b). No macroscopic signs of metallosis were observed, thus no serum metal levels were obtained. Surgical intervention included femoral head and neck removal, accurate debridement of soft tissues and removal of the well-fixed stem through a Wagner femoral osteotomy. Finally, a cementless Lima Revision stem (Lima Corporate, Udine, Italy) with cerclage wires to stabilize the femoral osteotomy was implanted (Fig. 1c). The bearing surface was ceramic on poly with a Biolox Delta head size 36 head. Intraoperative microbiological cultures confirmed the absence of infection.

Figure 1b. Case 1. Photograph showing the removed stem, neck and prosthetic head. A complete fracture of the modular neck occurring at the stem-neck junction is visible

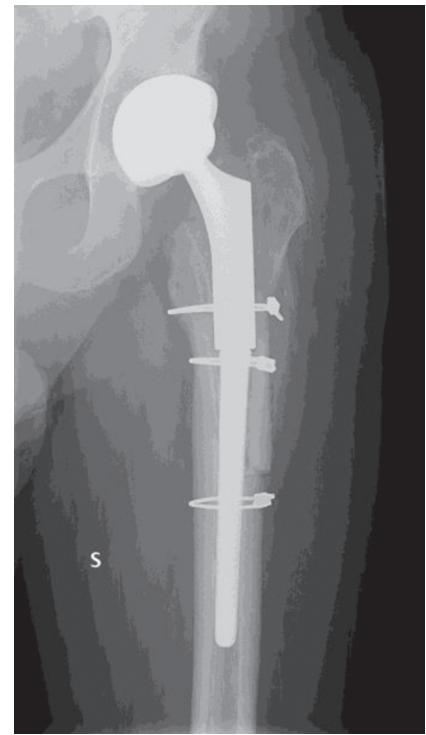
Figure 1c. Case 1. Left hip AP view post-operative radiographs showing implant revision

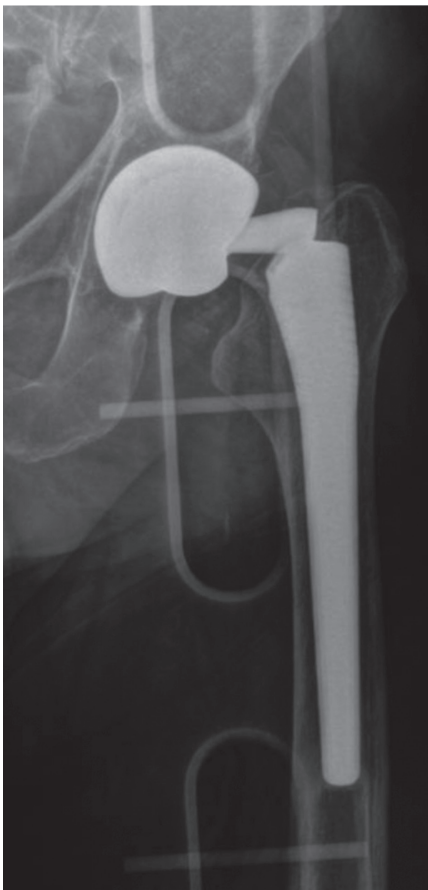
Postoperative course was uncomplicated. After 4 years from the index procedure, the patient referred to the emergency department for acute left hip pain with a subjective feeling of instability, without any reported traumatism. Radiological evaluation showed a fracture of the modular neck at the stem-cone junction (Fig 2a). The acetabular and femoral components resulted to be intact. There were no clinical, radiographic, or laboratory signs of infection.

Figure 2a. Case 2. Left hip AP view radiographs showing a complete fracture of the modular neck at the stem-neck junction

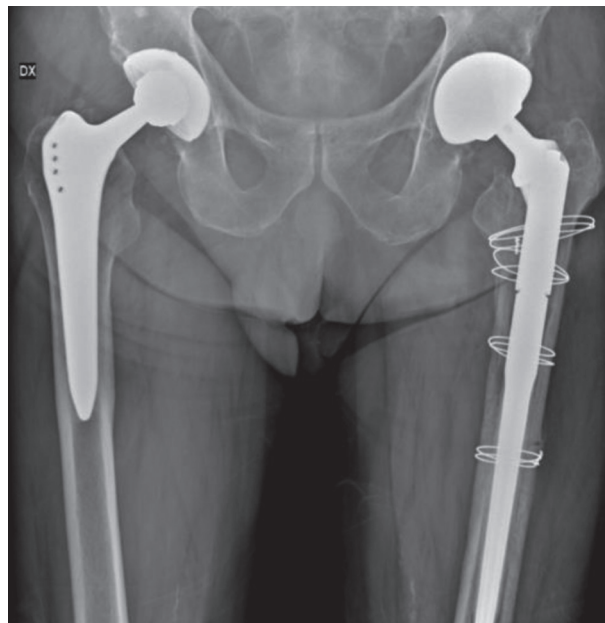
Figure 2b. Case 2. Pelvic AP view post-operative radiographs showing implant revision of the left hip

signs of metallosis, no iron particles or fibrosis were seen. Periprosthetic soft tissue were free from relevant alterations, being the fracture of the neck the only pathological feature. The well-fixed stem was removed via a Wagner's osteotomy, and revised with a MP Reconstruction Prosthesis (Waldemar Link, Hamburg, Germany). Four cerclage wires were inserted to secure the osteotomy (Fig. 2b).
