Early-stage radiological critical analysis of unsuccessful cases following a four-part fracture osteosynthesis of the proximal humerus: focus on the “P” sign

Summary. Radiological evaluation of complex intra-articular fractures of the proximal humerus is still challenging. Here, we describe the post-operative “P” sign as a reproducible radiographical mark of a varus reduction, performed by assembling a head-shaft angulation of less than 130 degrees. Our retrospective study was conducted in a group of subjects who previously suffered from proximal humerus four-part fractures. We evaluated the post-operative evolution of specific radiographical parameters that are of crucial prognostic significance: Cervix-diaphysis angle (HHSA), quality level of the orthopaedic reduction (insufficient, sufficient and good) based on a radiological generalized subjective overview, presence of calcar screws through the Philos plate. The final cohort included a group of 39 patients of 70.76 ± 8.3 years of age and an average follow-up of 7.2 months. The post-operative mean HHSA was 131.5 ± 9.4 . Interestingly, a positive correlation was detected between presence of the radiographical “P” sign in the pos

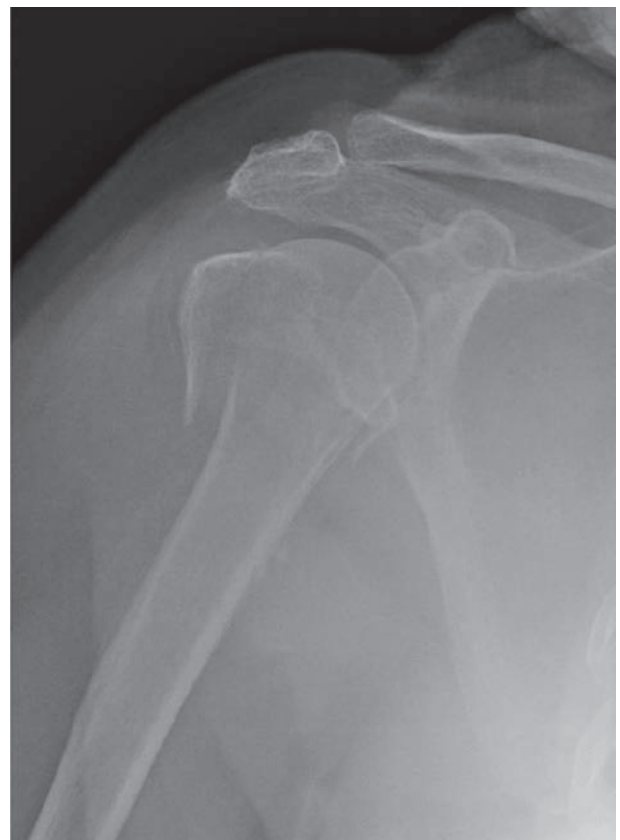
Figure 1. 4 Radiographs of a 75-year-old woman with a four-part fracture osteosynthesis of the proximal humerus: the “sunset” sign is visible in the anteroposterior view

Radiological evaluation of complex intra-articular fractures of the proximal humerus is still challenging. The “sunset” sign typically seen in an anteroposterior X-ray view is a reliable and consistent indicator of four-part fractures of the proximal humerus (1).

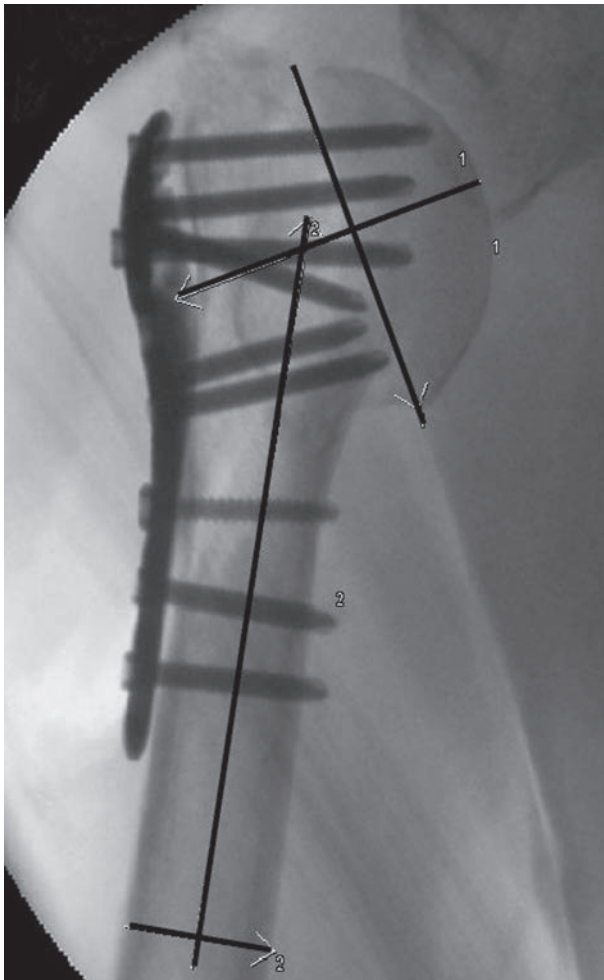
Figure 2. Postoperative radiograph demonstrated fracture reduction in varus ($119,61^\circ$) with the described “P sign”

Here, we describe the post-operative “P” sign as a reproducible radiographical mark of a varus reduction, performed by assembling a head-shaft angulation of less than 130 degrees. The radiological aspect of the

proximal humerus in such cases resembles to the “P” letter.

The radiographical “P” sign was defined as an indicator of reduced fractures with an HHSA being
